## **HYDRANT FLOW TEST ANALYSIS REPORT 2005**

PREPARED BY MICHAEL KRETSCHMANN, PE

FIRE PROTECTION ENGINEERING GROUP

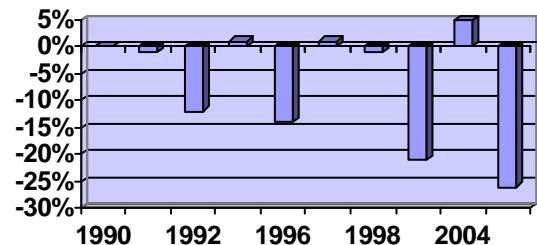
PERCENT FLOW CHANGE FROM 1990

**Piping Condition** is rated "Poor" since the flow trend is losing capacity at roughly 8% over the last 15 years.

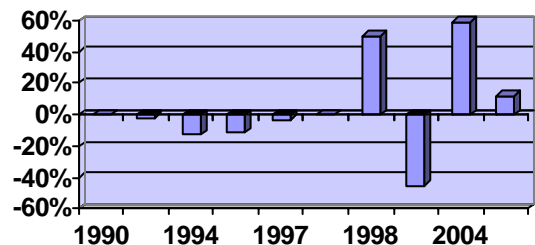
PERCENT FLOW CHANGE FROM 1990

**Piping Condition** is rated "Poor" since the flow trend is losing capacity.

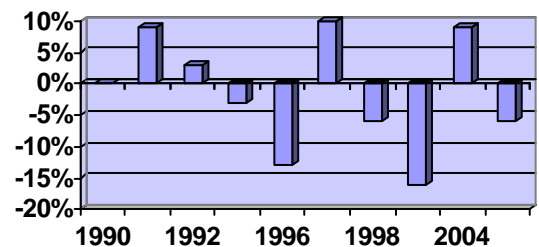
PERCENT FLOW CHANGE FROM 1990

**Piping Condition** is rated "Fair" since the flow trend is losing capacity at roughly 3% over the last 15 years.

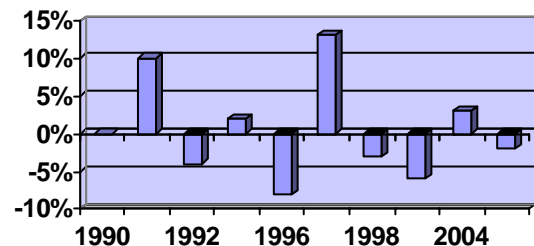
PERCENT FLOW CHANGE FROM 1990

**Piping Condition** is rated "Fair" since the flow trend is losing capacity at roughly 2% over the last 15 years.

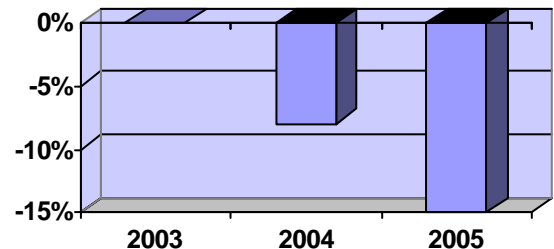
PERCENT FLOW CHANGE FROM 2003

**Piping Condition** rated "Poor" since the flow trend is losing capacity at roughly 15% over the last 3 years.

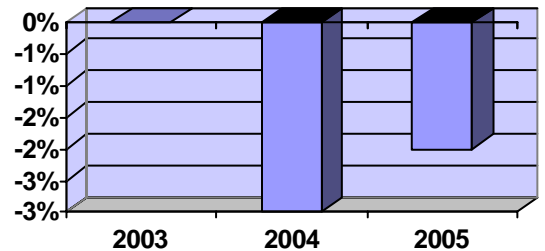
PERCENT FLOW CHANGE FROM 2003

Static pressures have remained relatively consistent (~69 PSI). These constant static pressure readings cannot be explained by apparent changes in either piping condition or day to day water demands. Further investigation by means of a hydraulic flow model study is required to understand the trend.

**Piping Condition** rated "Poor" since the flow trend is losing capacity at roughly 2% over the last 3 years.

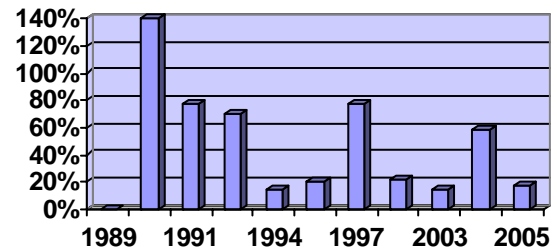
PERCENT FLOW CHANGE FROM 1989

**Piping Condition** is rated "Poor" due to a decrease in available flow by 12% in the last 16 years.
